# Tree Condition Assessment Report

Site: **Street, FERNTREE GULLY.**

**16<sup>th</sup> February 2023 - V1**

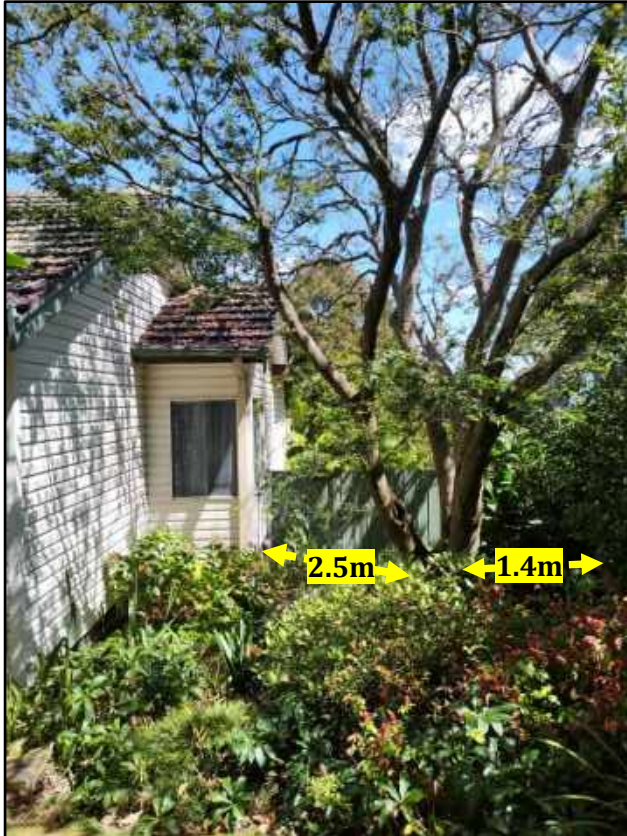
4.4. The site is residential block with an existing single story weatherboard dwelling. The subject tree is located within the front yard of the site along the northern boundary with the outside of the base of its trunk within 2.5m of the nearest corner wall of the dwelling and within 1.4m of the boundary paling fence (**Figure 1**).

**Figure 1:** Showing the location of the subject tree – 2.5m from dwelling and 1.4m from fence.

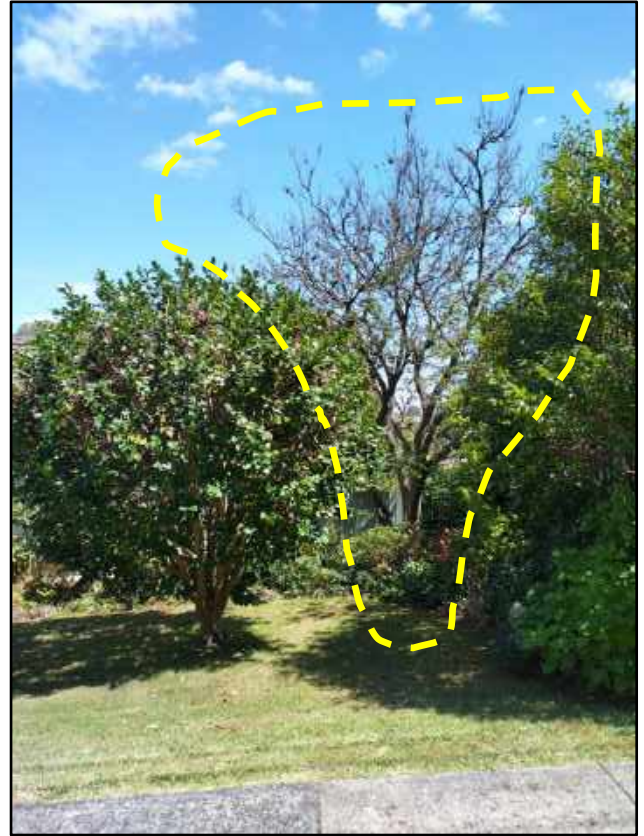
**Figure 2:** Showing the very sparse canopy coverage.

4.5. The subject tree was observed to appear in poor health with a very sparse canopy cover, high volume epicormic shoots throughout the canopy and moderate volume deadwood (Figure 2). The structure of the tree has assessed as poor because of the observed history of large poorly pruned/lopped branches which has caused the branch stubs to dieback and create probable entry points for decay within the trunk. Numerous large pockets of decay areas were observed along sections of 3 of the 4 main central leaders along with large dead/dying branches within the upper canopy. (**Figures 3, 4, 5 & 6**). Lower trunk cambial dieback and decay (**Figure 7**).

- 6.1. I support the residents request and concerns for the removal of the subject tree on the basis that it is in decline, highly unlikely that it will ever recover fully and has that it has become hazardous as it starts to fall apart.
- 6.2. The loss of canopy should be replaced with the planting of a replacement tree species which is capable of reaching a mature height of 10+m although be positioned within the site in a location sufficiently set from the dwelling and any associated neighbouring dwellings to ensure there are no future conflicts from the new tree's roots and/or canopy.
- 6.3. The applicants should apply to Knox City Council for a permit to remove the subject tree through the VicSmart application process.

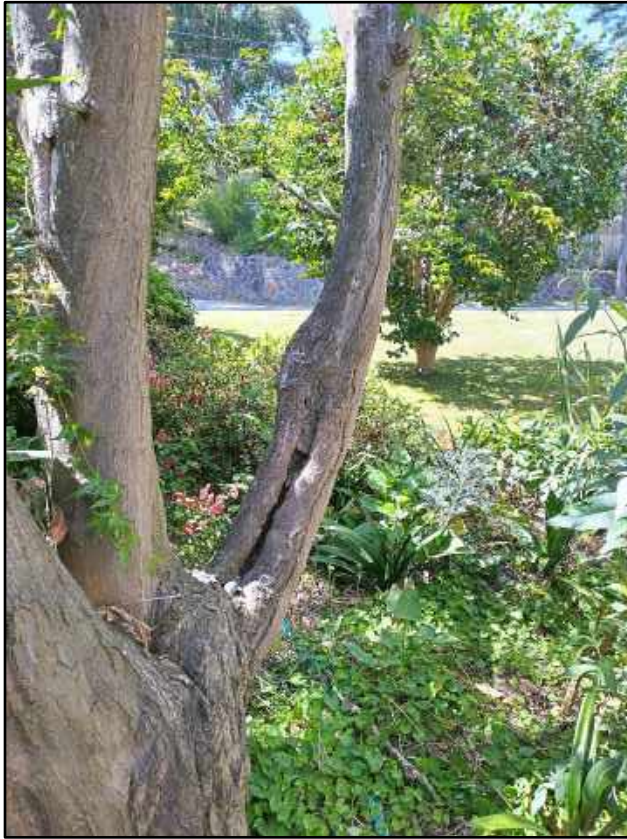
**Figure 3:** Showing decay in leader.

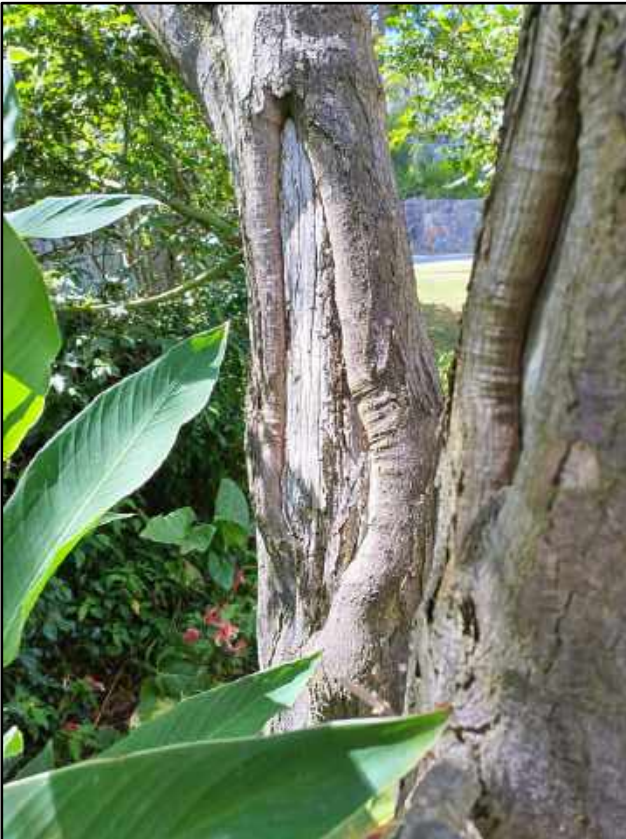
**Figure 4:** Showing additional decay and cambial dieback in the other two leaders.

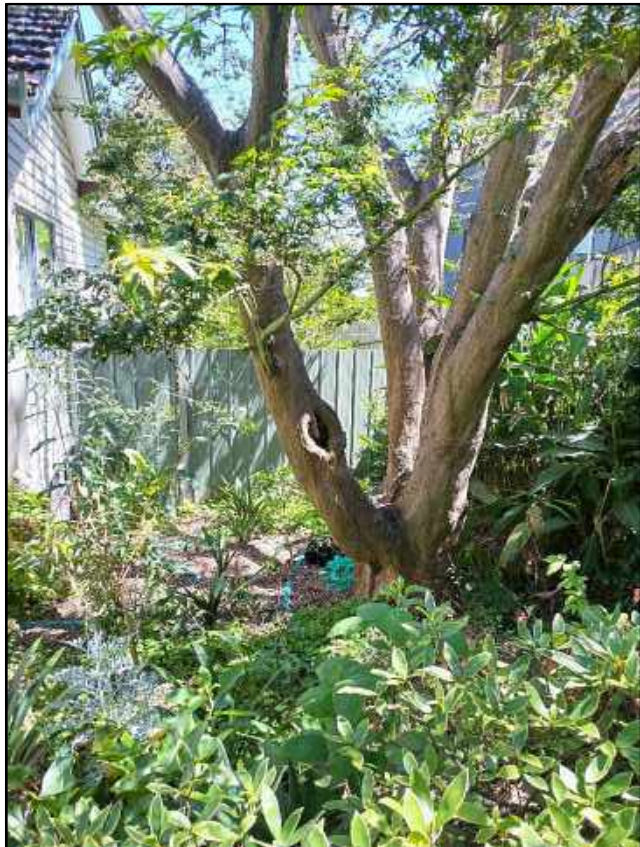
**Figure 5:** Showing decay pocket opposite side of leader as shown in Figure 3.

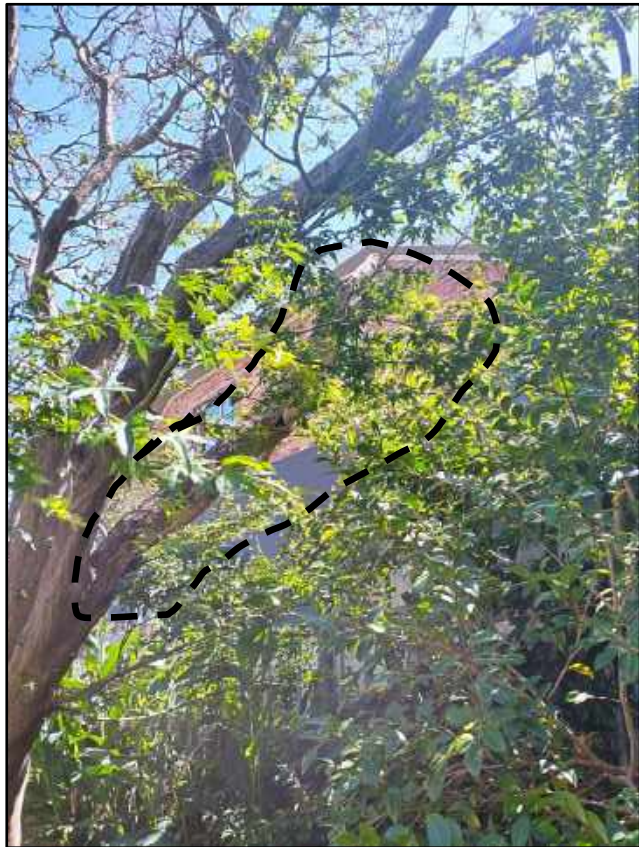
**Figure 6:** Showing dead lopped branch.

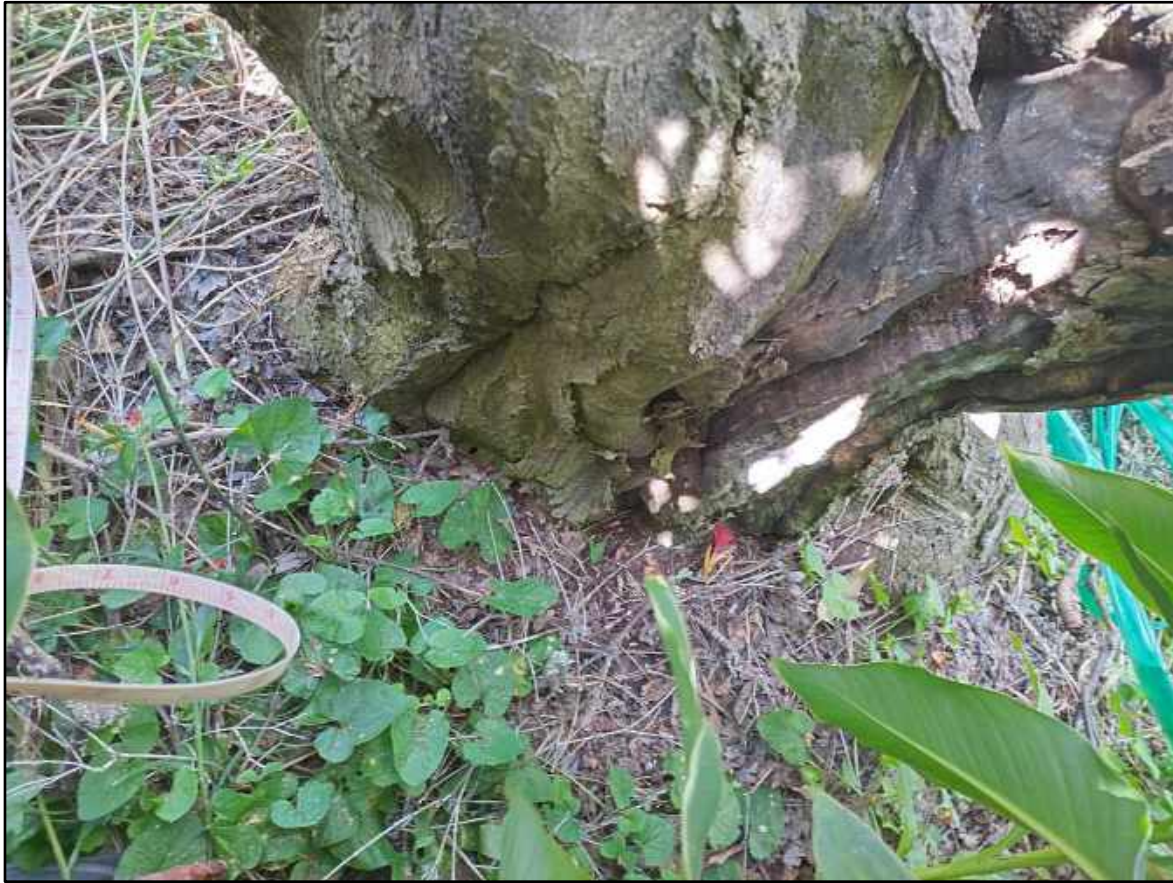
**Figure 7:** Showing the lower trunk cambial dieback and decay.
